Report Date: 6<sup>th</sup> August 2008  
Report Compiled By: Neil Stapleton

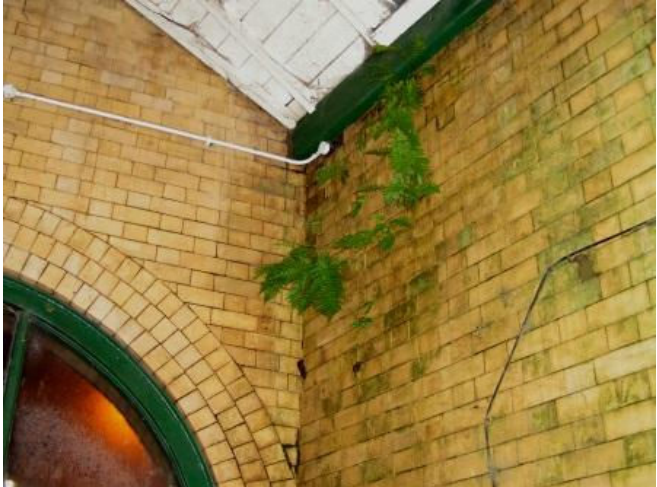
<p><b>Photo A</b></p> <p>The wall above the entrance way showing ferns growing from the brickwork and extensive mould/lichen growth.</p>

Walls (above whitewash)	Some vegetation growing and generally quite dirty (see photo A).

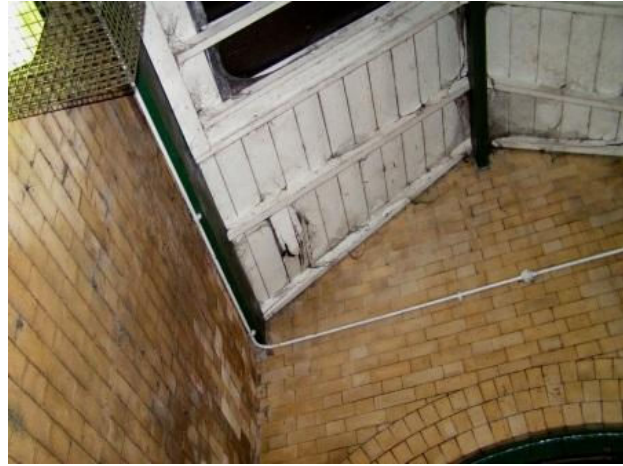
**Photo B**

Roof	Dirty. Two damaged planks in ceiling near street wall are leaking into entrance way when raining (photo B). In need of general care and cleaning.
Lights	OK

The roof of the entrance way showing broken roof timbers.

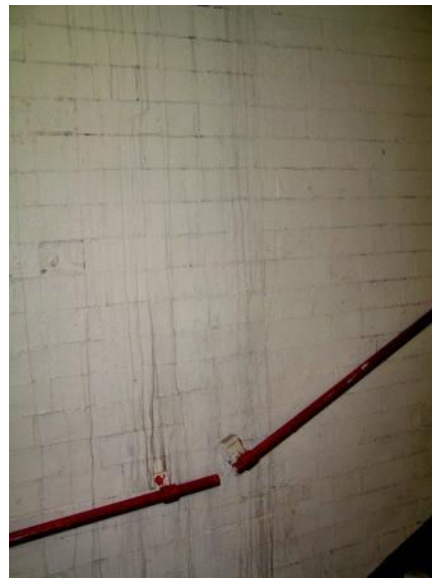
**Photo C**

Poster Cases	OK.
Stairs	OK but need thorough sweeping to remove dust and wood shavings from canopy renovation.
Walls (whitewashed)	Some staining from leaking roof (photo C).

Staining on the upper stairway walls caused by leaks from the stairway roof.

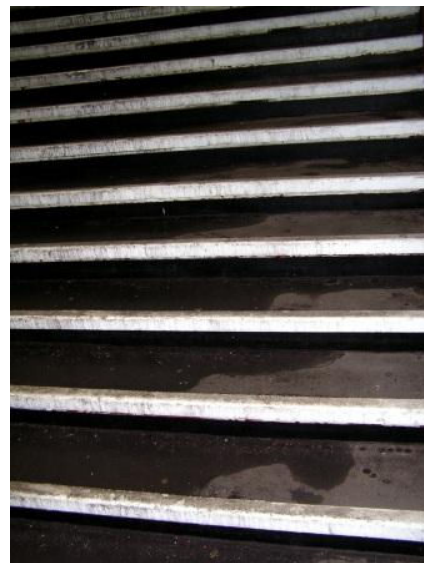
**Photo D**

Roof	Leaks badly onto stairs and walls during rain due to theft of flashing from roof in May (photo D).

The upper flight of stairs showing extensive puddles and wet surfaces after rain.

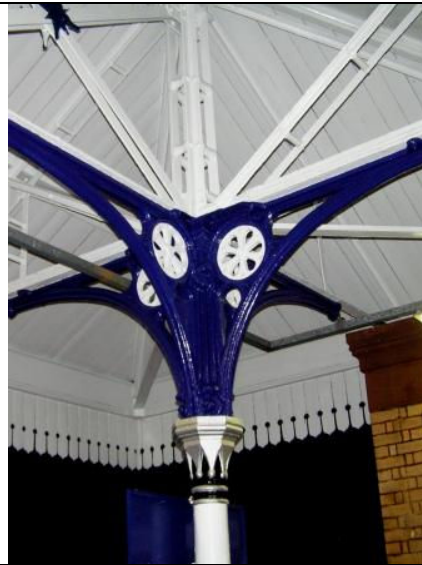
**Photo E**

The canopy repainting has finished this month and has greatly improved the platform area's appearance.

This was the most heavily overflowing pillar before being cleaned out during the repainting work.
