Report Date: 5th November 2008
Report Compiled By: Neil Stapleton

Station Frontage & Approach

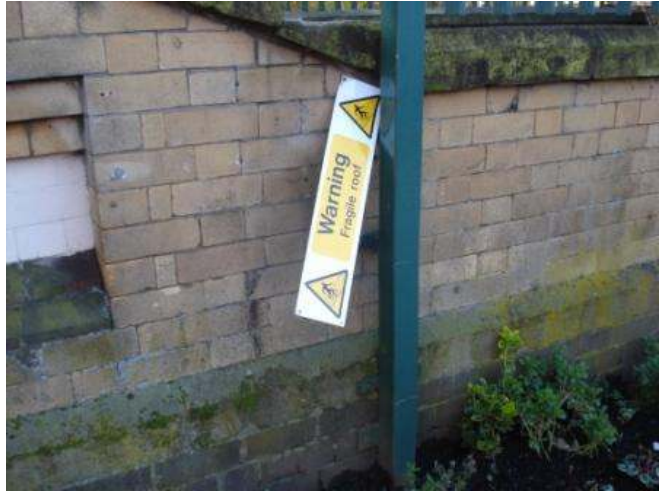
Photo B

☹️ Litter Bin	Missing since 21 st Sept.
Shelter & Seats	OK. Some graffiti on shelter.
Canopy	OK
☹️ Pillars	Grffiti reported last month has been painted over. 3 rd pillar on up platform showing fresh signs of rusting since recent repainting – this pillar’s gutter is clearly not working properly (see photo C)
Platform Surface	Possible signs of long-term subsidence by 3 rd pillar on South (down) platform.
Platform Edge	White line OK
North (Up) Flower Bed	OK. New winter flowers planted by FOWS this period.
South (Down) Flower Bed	OK.
Free-standing Planters	OK.
☹️ Platform Signs	“No Smoking” sign stolen from top of stairs (see Photo A).
☹️ North (Up) platform walls.	Grffiti reported last month has been painted over. Yellow safety sign has been pulled further away from wall since last month (see photo B).
South (Down) platform walls.	OK.

Vandalised safety notice on Manchester (up) platform.

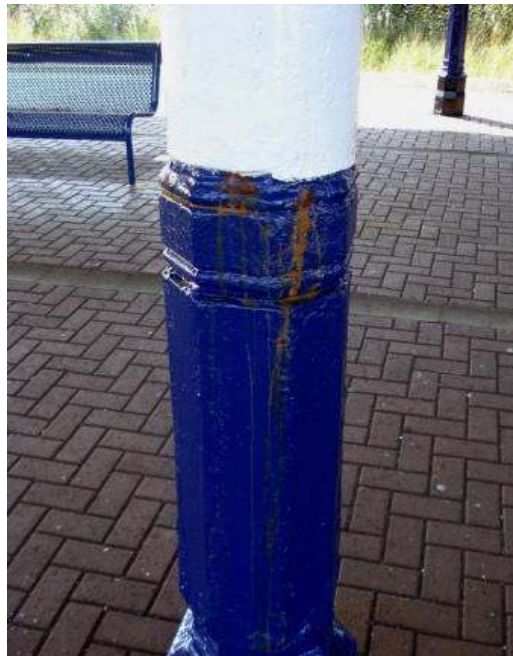
Photo C

Rust damage on up platform 4th pillar.
