Report Date: 6th April 2008
Report Compiled By: Neil Stapleton

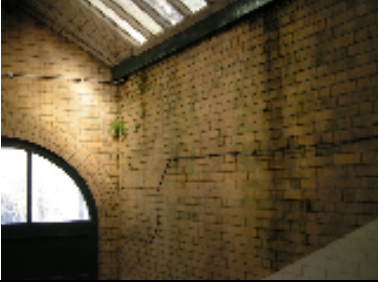
☹ Litter Bin	Missing
Poster Cases	OK
Stairs	OK
Walls (whitewashed)	Some new graffiti. Walls are fairly clean having recently been scrubbed by FOWS.
☹ Walls (above whitewash)	Some vegetation growing and generally quite dirty (see photo A).
☹ Roof	Very dirty. Two damaged planks in ceiling.
Lights	OK

A. Dirty walls with vegetation above lower stairway.

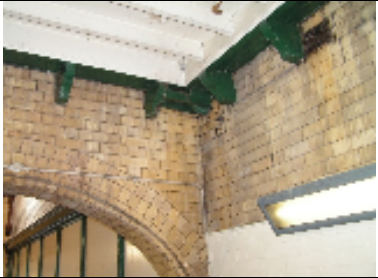
☹ Poster Cases	Some graffiti on Police poster case.
Stairs	OK
Walls (whitewashed)	Clean having been scrubbed by FOWS this morning (extensive mud & blood stains removed).
☹ Walls (above whitewash)	Very dirty.
☹ Roof	Leak from a broken conduit visible in corner above Police poster case (photo B).
Lights	OK

B. Broken conduit leaking into upper stairway.
