Report Date: 24th May 2009
Report Compiled By: Neil Stapleton

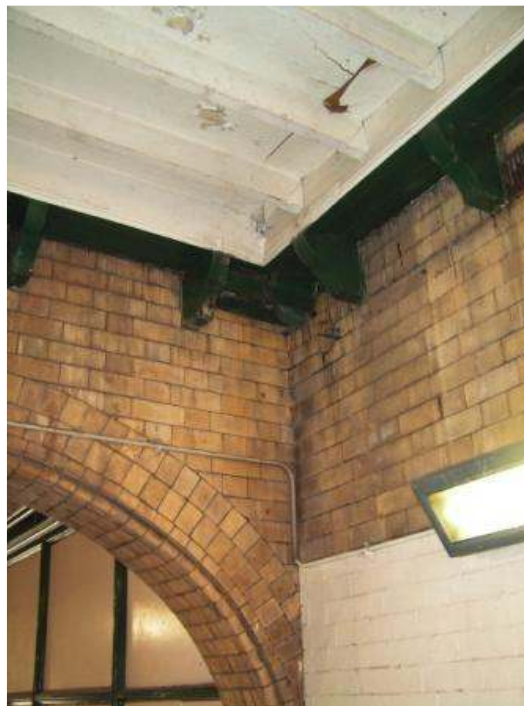
Roof	Leaking heavily from cracked conduit in ceiling at end of Booking Hall (photo A). In need of general repairs. Booking Office staff report severe leaking from roof in office during rain.
Lights	OK

Photo A.
Cracked conduit in Booking Hall ceiling
which drips heavily during rain.

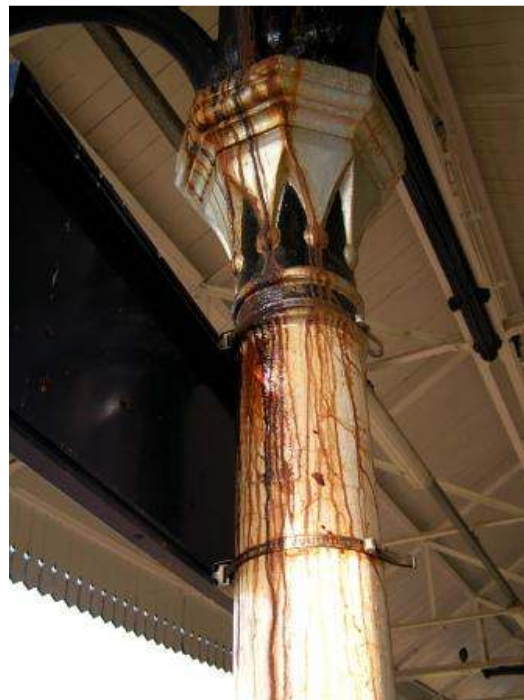
Pillars	1 st and 3 rd pillar on up platform show fresh signs of rusting since 2008 repainting. 1st pillar is presumed to be blocked as rusting has become noticeably worse this month (see photo B).
Platform Surface	Still some problems with excessive pigeon mess. Possible signs of long-term subsidence by 3 rd pillar on South (down) platform.
Platform Edge	"Mind The Gap" warnings have not yet been added.
North (Up) Flower Beds	OK. Weeded by FOWS.
South (Down) Flower Bed	OK. Weeded by FOWS.
Free-standing Planters	OK.
Platform Signs	OK.
North (Up) platform walls.	OK.
South (Down) platform walls.	OK.

Photo B.
Evidence of blocked conduit causing
corrosion to 1st pillar on Up
(Manchester) platform.
