Report Date: 16<sup>th</sup> January 2010  
Report Compiled By: Neil Stapleton

### Station Frontage & Approach

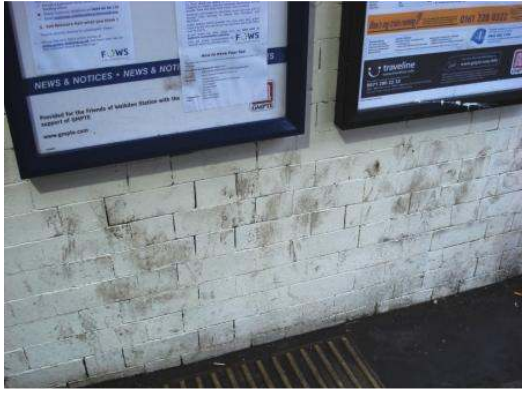
<p><b>Photo A</b></p> <p>Lower staircase before cleaning by FOWS</p>

Litter Bin	OK.
Poster Cases	OK.
Stairs	Generally OK. Like the upper stairway, the stairs are in need of a deep clean and repainting of faded stair-edge lines.
Walls (whitewashed)	Were very dirty but cleaned by FOWS this morning (see photos A & B)
Walls (above whitewash)	OK.
Roof	OK.
Lights	OK

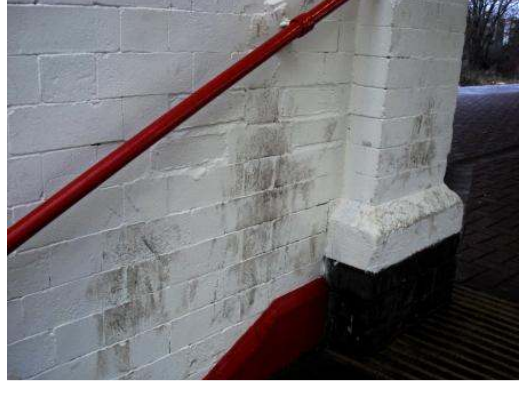
<p><b>Photo C</b></p> <p>Upper staircase before cleaning by FOWS</p>

Poster Cases	OK
Stairs	Lines on step-edges are fading and need to be repainted. However, problem of slipping caused by leaking roof has been fixed by Network Rail repairs.
Walls (whitewashed)	Were very dirty but cleaned by FOWS this morning (see photos C & D)
