Report Date: 5<sup>th</sup> October 2008  
Report Compiled By: Neil Stapleton

## Station Frontage & Approach

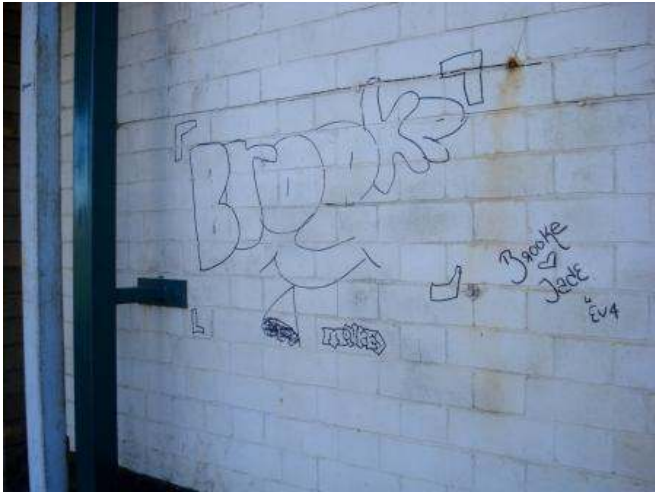
<p><b>Photo A</b></p> <p>Graffiti on north platform wall.</p>

☹️ Litter Bin	Missing since 21 <sup>st</sup> Sept.
Shelter & Seats	OK.
😊 Canopy	OK – canopy repainted by Northern since graffiti in rafters reported last month.
☹️ Pillars	Graffiti reported last month has been painted over. 3 <sup>rd</sup> pillar on up platform showing fresh signs of rusting since recent repainting – this pillar's gutter is clearly not working properly (see photo D)
Platform Surface	Possible signs of long-term subsidence by 3 <sup>rd</sup> pillar on South (down) platform.
Platform Edge	White line OK
North (Up) Flower Bed	OK. Weeded by FOWS today. Needs more winter flowers – FOWS to plant next week.
South (Down) Flower Bed	OK. Weeded by FOWS today.
Free-standing Planters	OK.
Platform Signs	OK.
☹️ North (Up) platform walls.	Fresh graffiti this weekend (see photos A & B). Yellow safety sign has been pulled partly away from wall.
South (Down) platform walls.	OK.

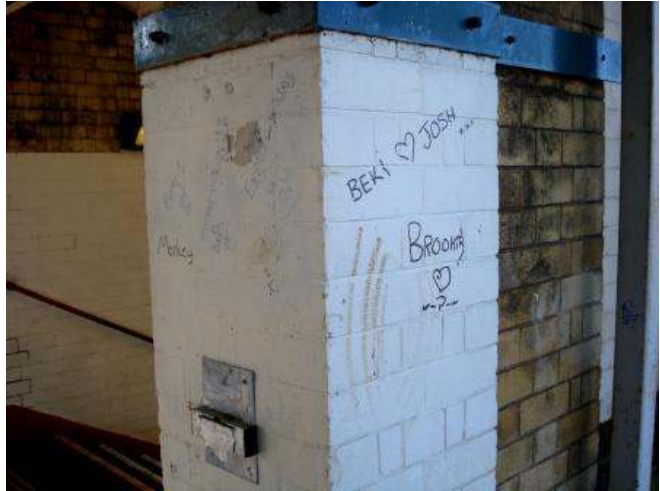
**Photo B**

Missing litter bin and graffiti on north platform wall.

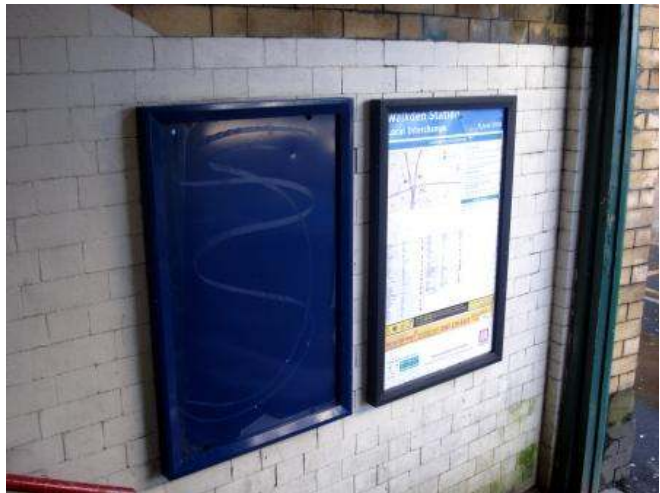
**Photo C**

☹	Litter Bin	Missing since 21 <sup>st</sup> Sept.
☹	Poster Cases	Two poster cases nearest street have smashed perspex covers since 21 <sup>st</sup> Sept. (see photo C).
	Stairs	OK.
☹	Walls (whitewashed)	Graffiti around site of missing litter bin.
☹	Walls (above whitewash)	Generally dirty.
☹	Roof	Dirty. Two damaged planks in ceiling near street wall are leaking into entrance way when raining. In need of general repair and cleaning.
	Lights	OK

Poster cases with smashed perspex covers.
